## AVIATION INVESTIGATION REPORT

A04A0057

### WING SCRAPE DURING A REJECTED LANDING

BOEING 727-225 C-GCJB

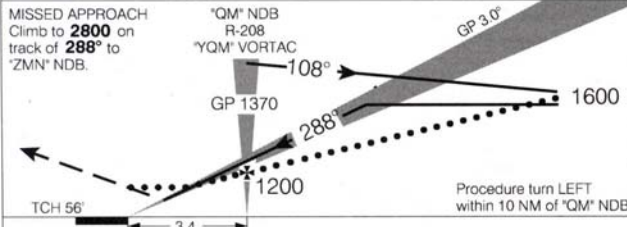
CYQM

<b>ATIS</b> 128.65	<b>ARR</b> 124.4 384.8	<b>TWR</b> 120.8 236.6	<b>GND</b> 121.8 275.8	<b>DEP</b> 124.4 384.8	<b>ELEV 232</b>
					<b>TDZE 29 232</b>

SAFE ALT 100 NM **4400**

CATEGORY	A	B	C	D														
ILS	<b>432</b>	(200)	1/2 RVR 26															
LOC LOC/VOR	<b>560</b>	(328)	1 RVR 50															
NDB	<b>600</b>	(368)	1 RVR 50															
CIRCLING	<b>740</b> (508) 1 1/2	<b>740</b> (508) 2	<b>840</b> (608) 2

<table><tr> <td colspan="5">*QM* NDB to MAP 3.4 NM</td> </tr></table>

The Moncton 0200 weather report received during descent for the first approach was as follows: estimated 1100 feet overcast, visibility 10 sm. Based on this report, the crew planned for and executed a straight-in, localizer back-course approach to Runway 11, anticipating no difficulties. Consequently, they did not plan for a diversion, and the approach choice was based upon the most expedient approach for the reported weather conditions. Had the reported weather reflected the actual lowered ceiling and visibility, the crew would likely have planned for a diversion and conducted an ILS approach to Runway 29 as their first approach. This option would have increased the chances of landing successfully on the first approach and avoided the low fuel state.
